**Rush Creek Subdivision
Quite Stream, Falling Brook, Silent Spring, Painted Leaf,
Rush Creek Way
Maryland Heights MO 63043**

Client(s): Creek HOA
Inspection Date: 6/7/2021
Inspector: Don Norman ,

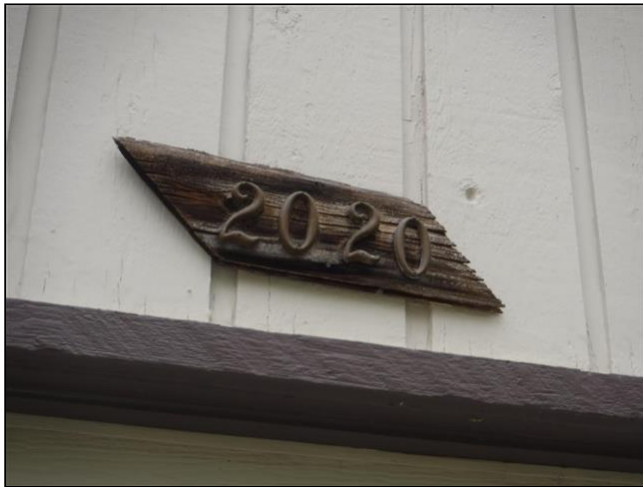
Post visible numbers at all units where needed.

QUIET STREAM - EAST BUILDING - We recommend posting visible unit numbers, where needed, on all units to aid emergency responders.

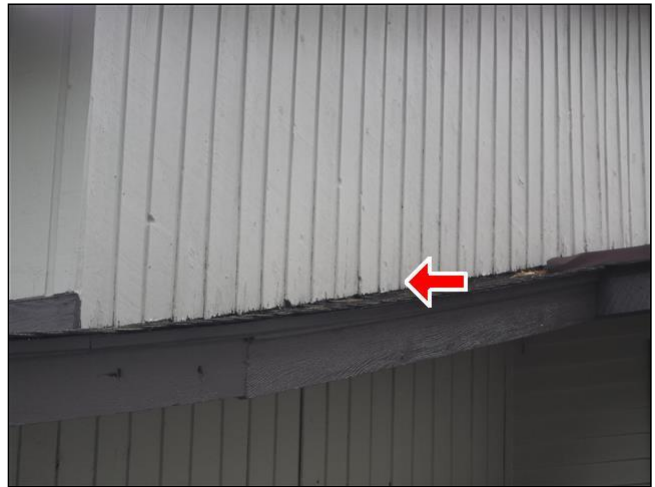
2022 - Post visible address. Siding damage at downspout on second floor. Minor siding damage at roof line.

2022 - Minor decay to siding.

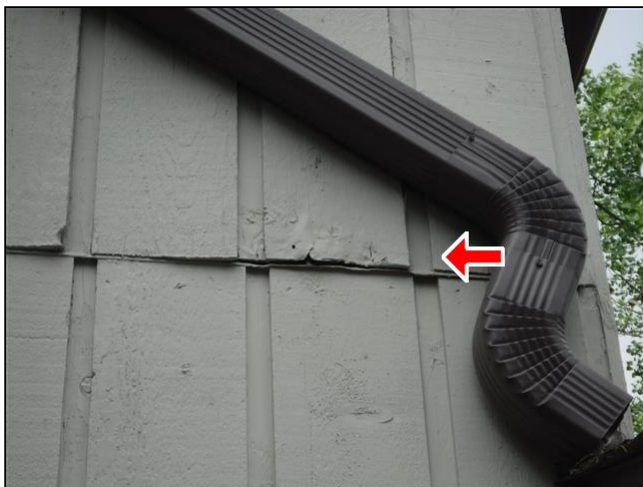
2022 - Siding damage.

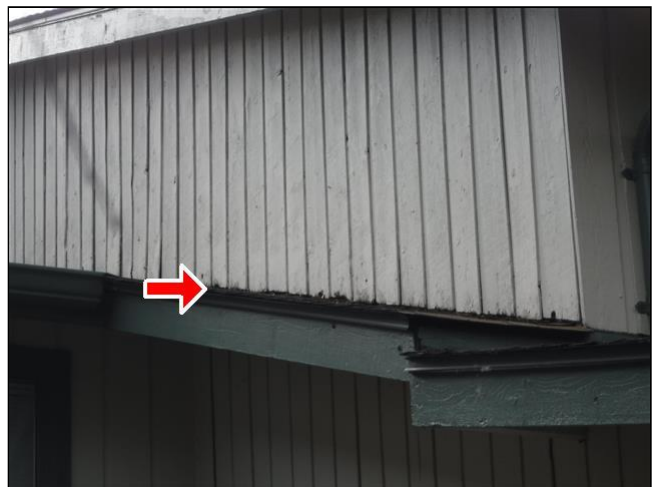
2028 - Post visible address. Minor siding damage at roof line in front. Damaged siding at rear.

2028 - Minor siding damage.

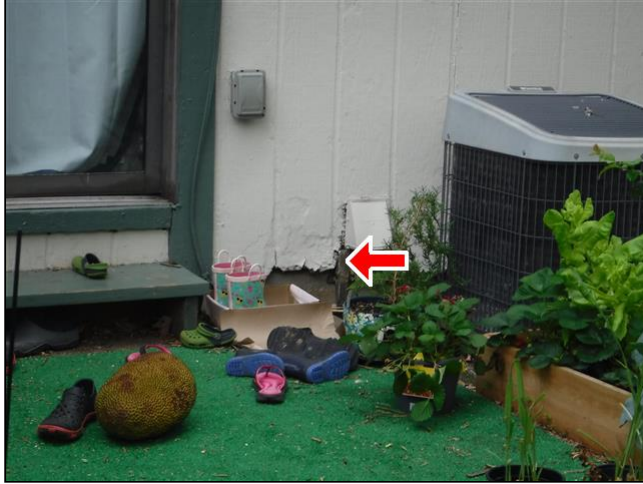
2028 - Damaged siding.

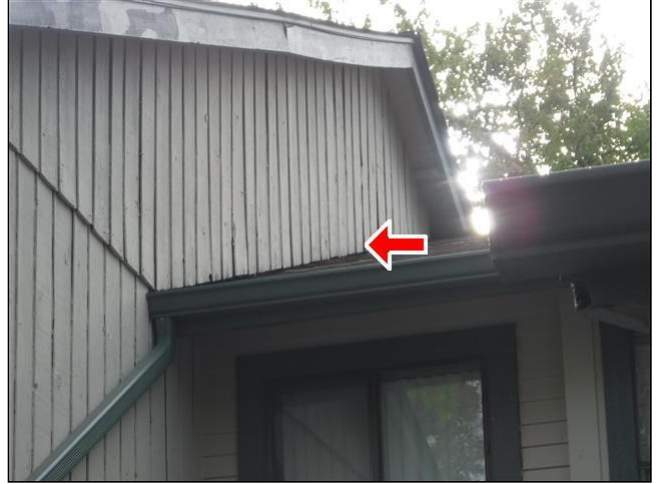
2030 - Front garden overgrown. Siding damage at roof. Rear yard is overgrown with standing water. 2032 - Post visible address.

2030 - Minor siding damage.

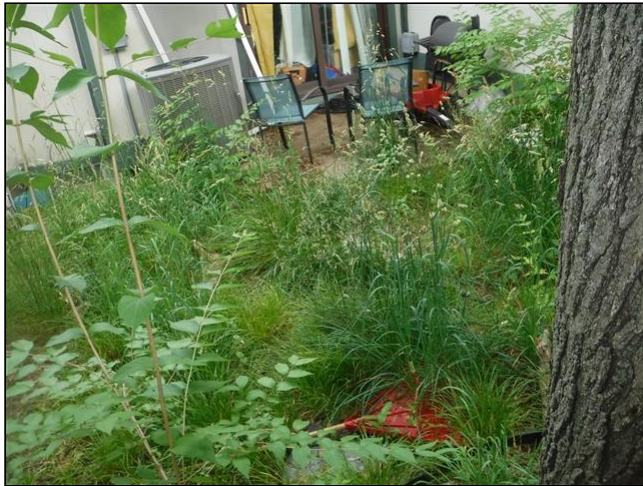
2030 - overgrown rear yard.

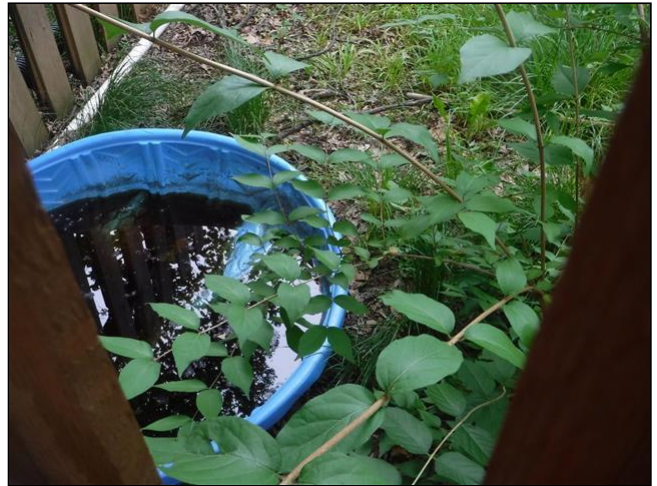
2030 - standing water rear yard.

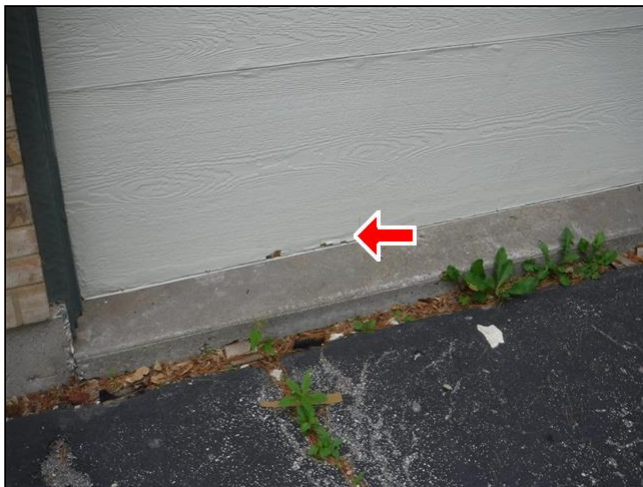
2034 - Post visible address. Garage door is deteriorated. Lot is overgrown. Damaged siding trim.

2034 - Garage door deterioration.

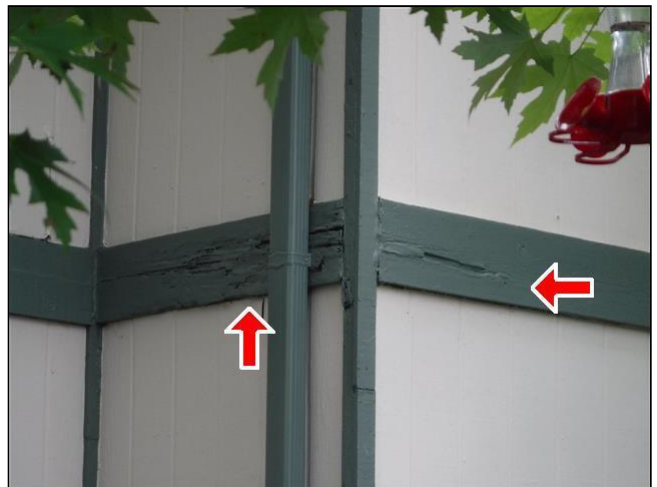
2034 - Siding trim decay rear elevation

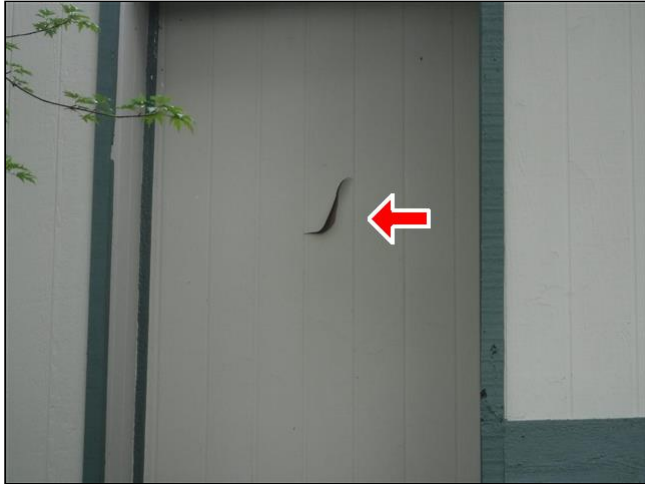
2036 - Post visible address. Peeling paint on rear elevation was observed.

2036 - Peeling paint at rear.

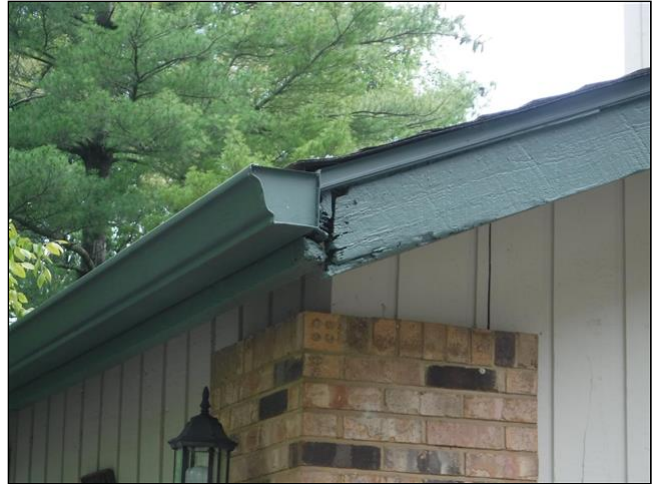
2038 - Post visible address. Rake fascia damage. Minor garage door damage. Siding damage at rear on chimney chase, siding and trim.

2038 - Rake fascia damage.

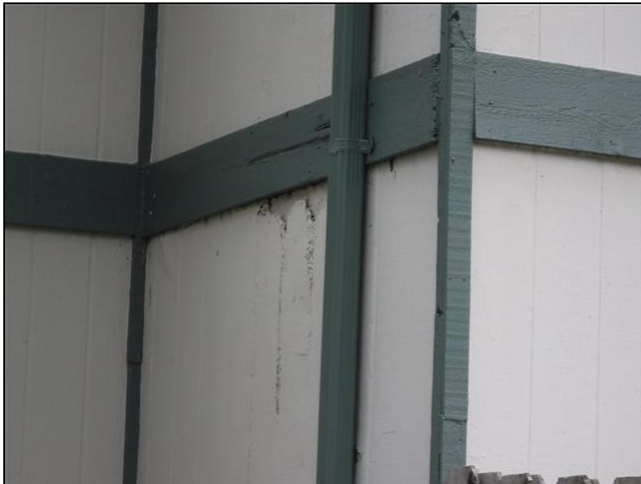
2038 rear - Siding damage.

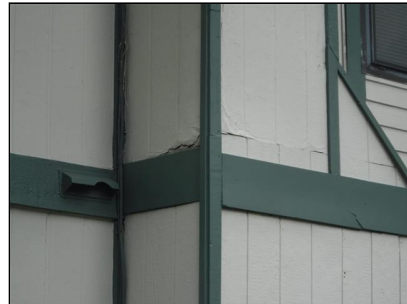
2038 rear - Chimney chase damage.

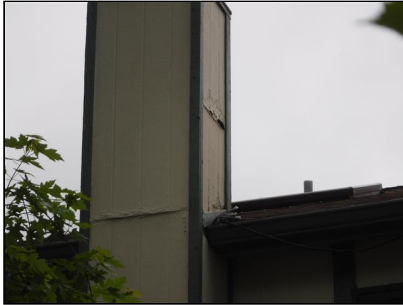
2038 rear - Chimney chase damage.

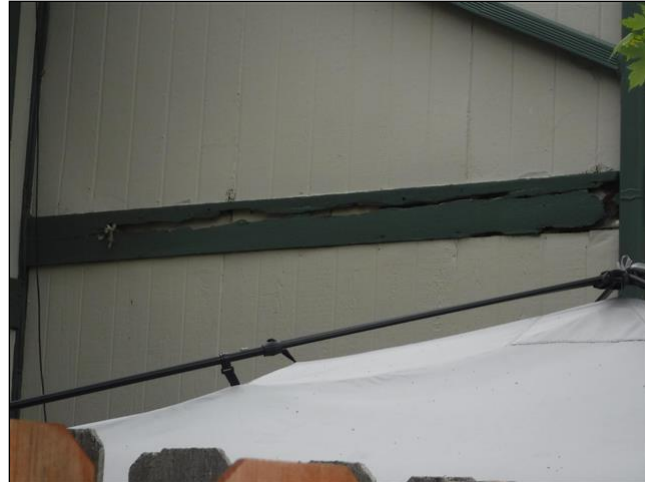
2038 rear - siding trim damage

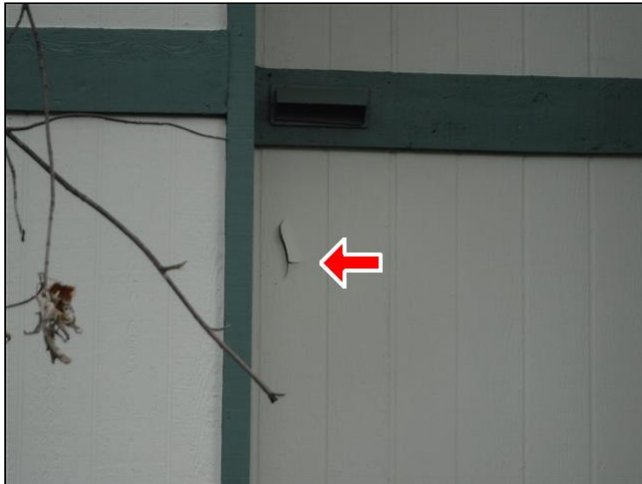
2040 Rear - Peeling paint.

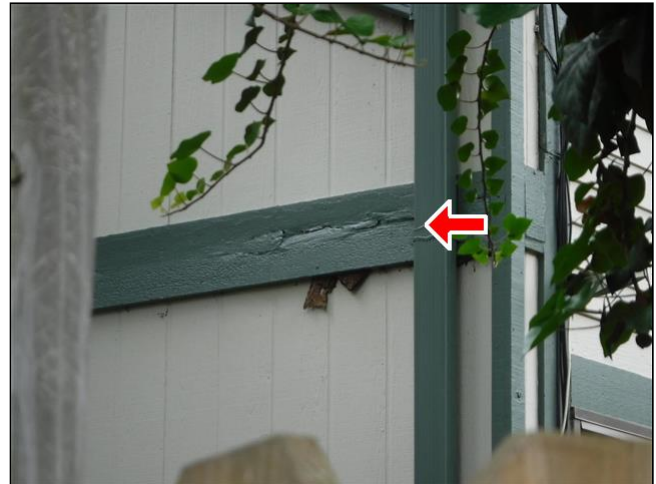
2044 - Rotted trim on side at rear elevation.

2044 rear - Rotted trim on siding.

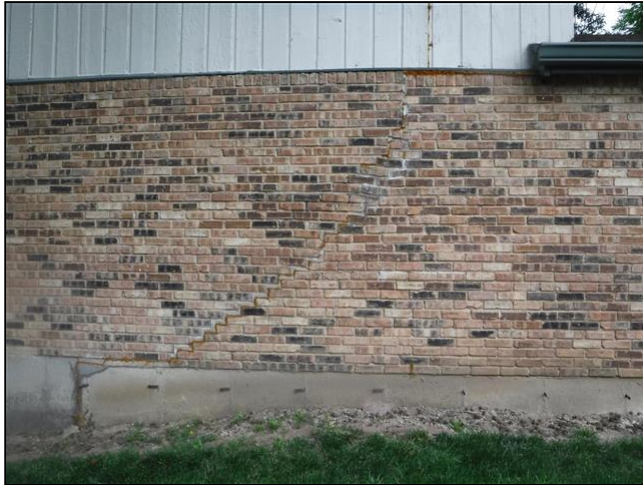
Settlement of the foundation on the south side of the building was observed. Rake fascia was damaged.

Settlement of building on south side.

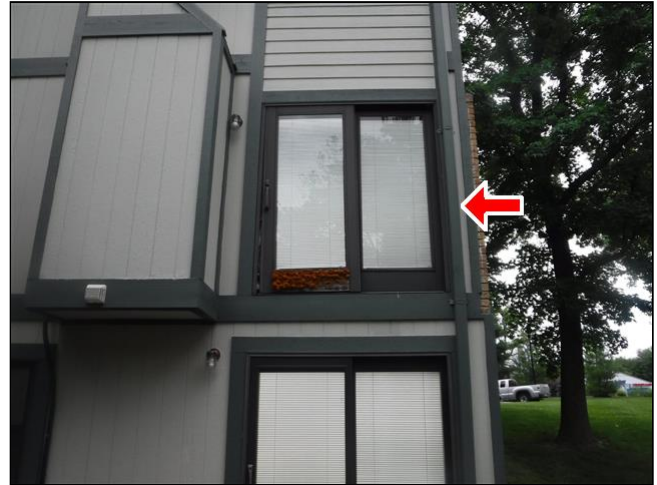
2025 - Damaged rake fascia board. Patio door at rear elevation is elevated above grade and poses a fall hazard.

2025 - Elevated patio door.

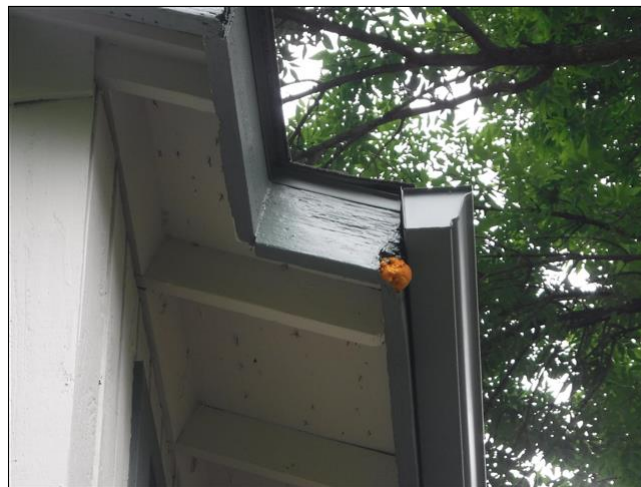
2025 - Damaged rake fascia.
