**BPG Inspection, LLC**

**Rush Creek subdivision, Quite Stream, Falling Brook,  
Silent Spring, Painted Leaf, Rush Creek Way  
Maryland Heights MO 63043**

Client(s): HOA  
Inspection Date: 8/26/2024  
Inspector: Mark Goodman ,

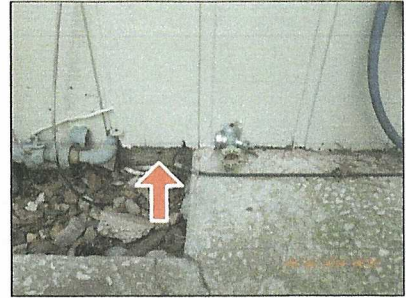
We noted peeling paint at the south end of the building.

Deterioration at siding at south end of building.

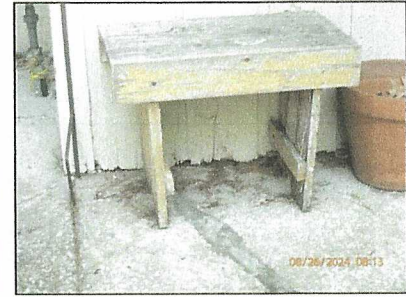
2044 - The soil is in contact with or above the bottom of the siding, which will result in water-damaged siding. The bottom edge of the siding has deteriorated at several locations, and there is some loose siding. The brick wing wall has settled, resulting in an open gap in the tuckpointing. There is a downspout that needs to be resecured to the siding. Noted wood decay and peeling paint at the back of the building.

2044 - Deteriorated siding at grade level.

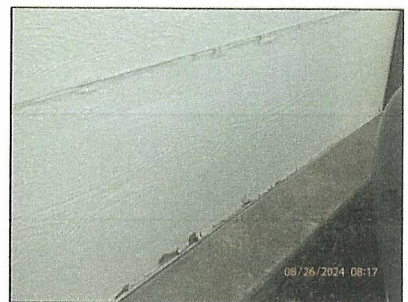
2034 - We noted deterioration at the garage door and form ties at the foundation that should be removed. Noted peeling paint at the rear of the building.

2034 - remove concrete form ties.

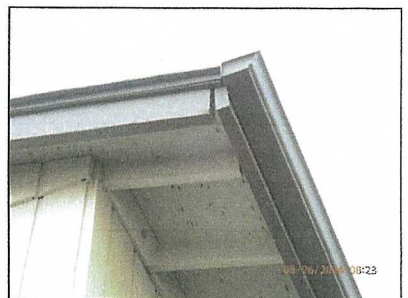
2020 - We noted some deterioration at the siding on the side of the garage, and the gutter board needs to be resecured to the roof rafters. There is also damaged wood at the chimney on the rear of the building.

2020 - Siding deterioration.

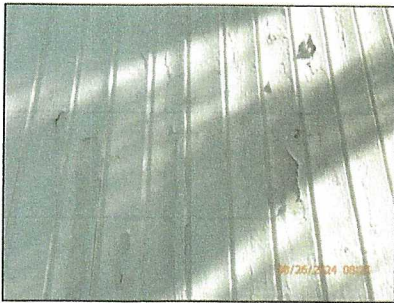
2020 - Loose gutter board.

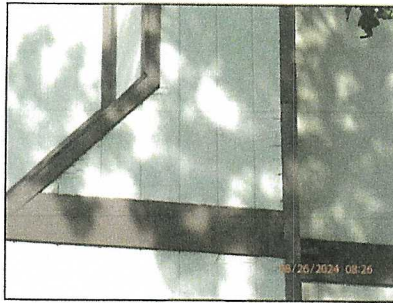
South end of building.

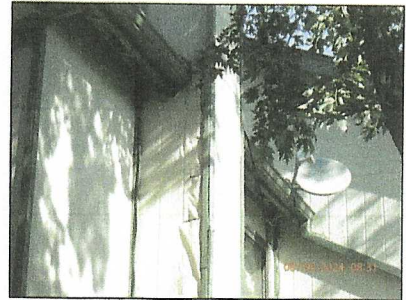
Damaged wood at chimneys.

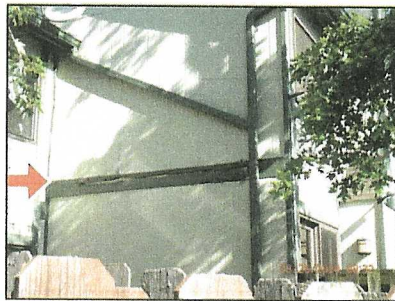
2038 - I recommend removing the form ties at the foundation and painting the garage door and jamb. Noted peeling paint at the rear of the building and damaged siding at the chimney.

2038 - Chimney

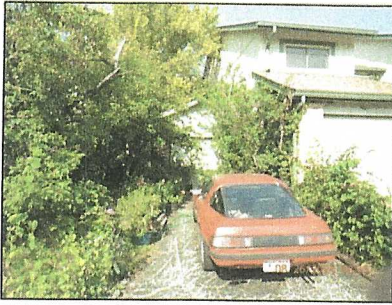
2035 - Noted heavy vegetation and recommend trimming vegetation away from the building.

2035 - Heavy vegetation.

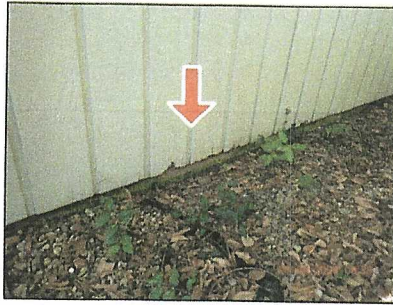
2033 - Noted wood deterioration at the bottom of the siding near the grade and at the garage door.

2033- Wood decay at the bottom of the siding.

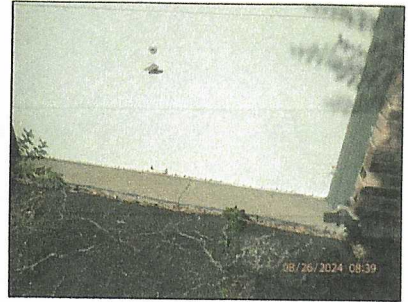
2033 - Garage door.

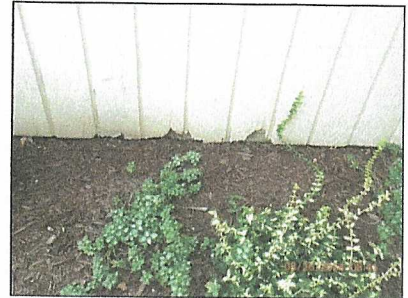
2025 - Noted deteriorated siding and wood decay at the bottom edge of the siding near the grade level and above the roof line. The top cap of the wall in front of the entries is also cracked and deteriorating.

2025 - Deteriorated siding

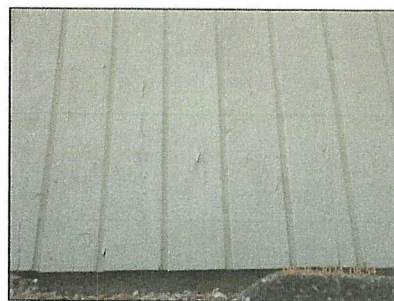
Pool House

We noted peeling paint on the exterior of the pool house and recommend painting it.

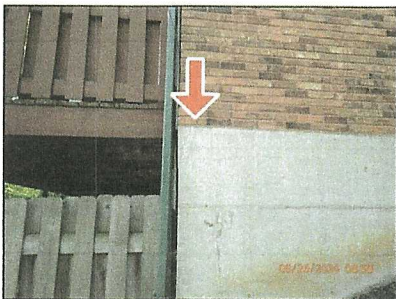
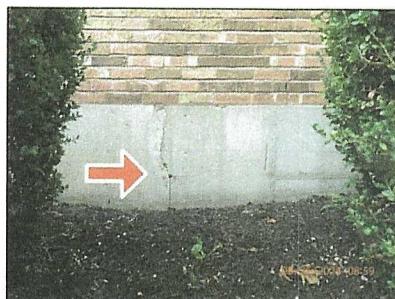
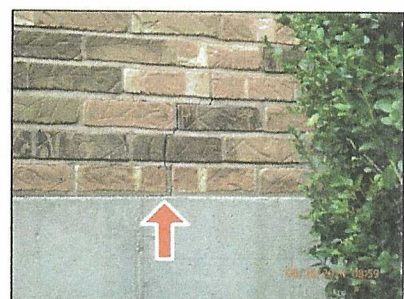
North end of building

On the north end of the building, I noted horizontal to angular cracking in the foundation wall and stair step cracking in the brick, possibly due to settlement. We also noted common fractures at the exterior corners of the foundation. This inherent condition normally results from the differential expansion of the concrete foundation and the masonry exterior. A downspout is not attached to the underground leader pipe, which may result in erosion.

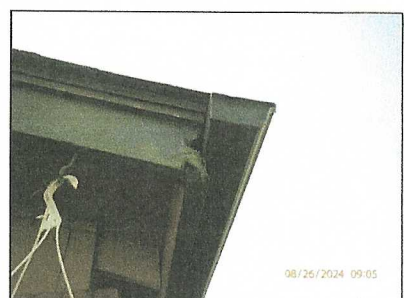
2038 - Noted damaged and deteriorated gutter board. Wood deterioration at the bottom edge of the siding above the roof line.

2038 - Damaged gutter board.

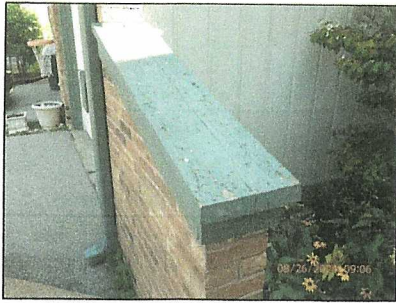
2036 - Noted deteriorated paint and caulking details at the garage door jamb and wing wall cap.

2036 - Deteriorated paint.

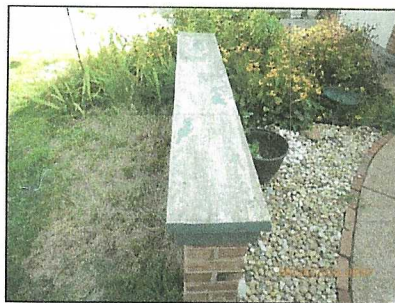
2034 - Noted deteriorated paint at the entry wall cap

2034 -Entry wall cap deteriorated paint.

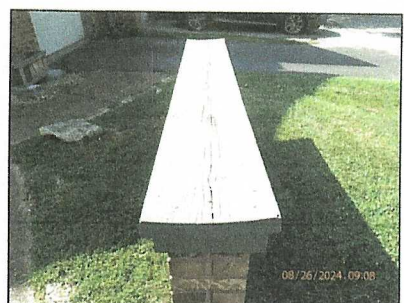
2032 - Noted deteriorated caulking details at the garage door jamb and a cupped cap board with deteriorated paint at the entry wall. There is also some minor wood deterioration at the bottom edge of the siding.

2032 - Entry wall cap.

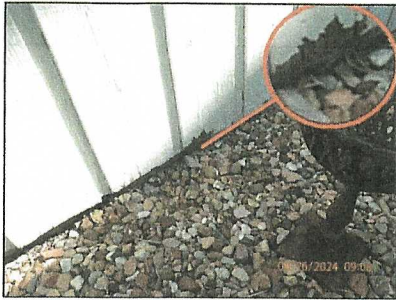
2032 - Siding deterioration.

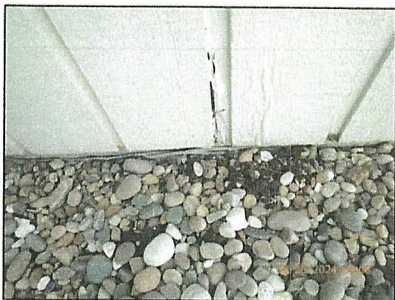
2030 - Noted peeling paint at the side of the garage on the siding.

2030 - Peeling paint.

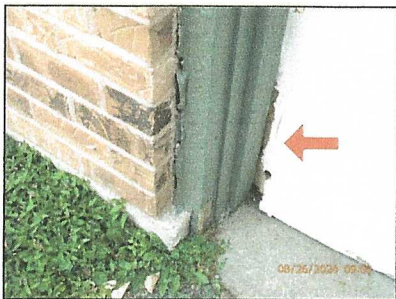
2028 - Noted deterioration and the garage door and paint finishes. The wing wall cap is warped loose, and the entry wall cap is damaged; both need to be replaced. there is also some deterioration at the bottom edge of the siding.

2028 - Deteriorated wood at garage door.

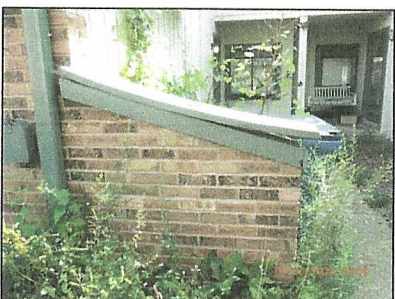
2028 - Wing wall cap.

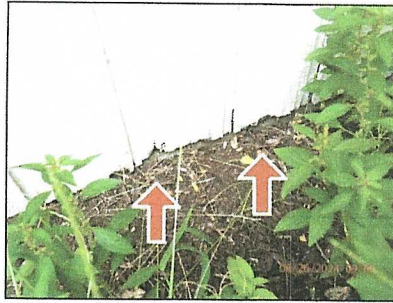
2028 - siding deterioration.

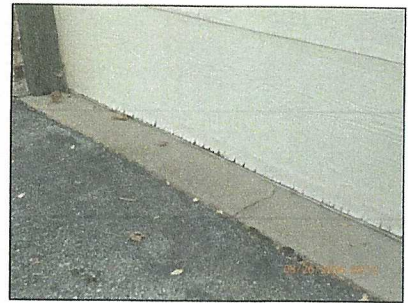
2026 - Post visible address. Garage door deteriorated. Stair step cracking in the brick at the right side of the garage door.

2026 - Garage door deteriorated.

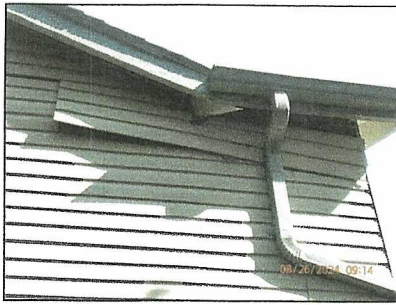
South end of building

On the south end of the building there is loose, displaced, and missing siding. Patch concrete at foundation wall.

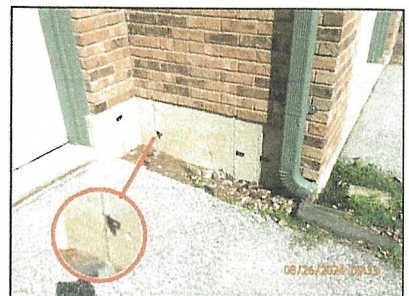
2031 - Form ties at the foundation wall should be removed. Deterioration at the garage door.

2031 - Form ties.

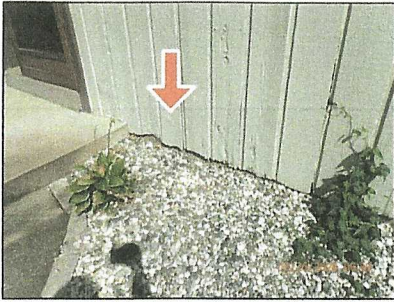
2037 - Deterioration at the bottom edge of the siding.

2037 Siding deterioration.

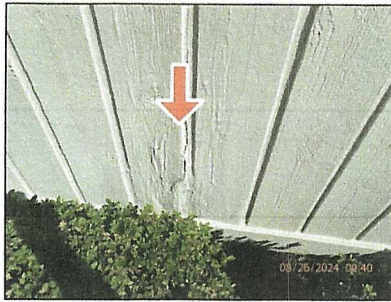
2041 - Siding.

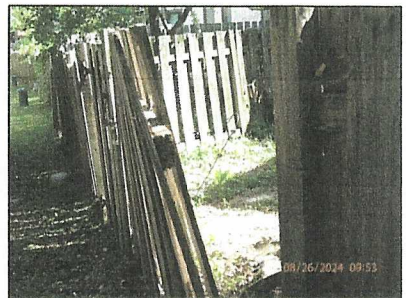
Noted loose, displaced and damaged fencing at the rear of the building.

rear of building - fencing.

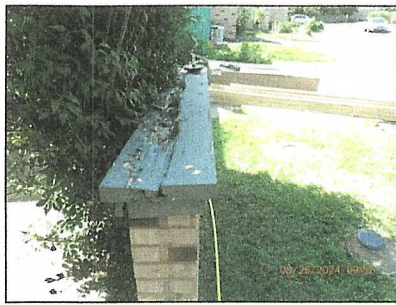
2046 - Deteriorated wood cap ant the entry wall.

2046 - Entry wall cap.

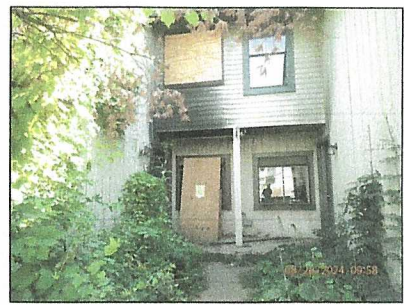
Fire damage

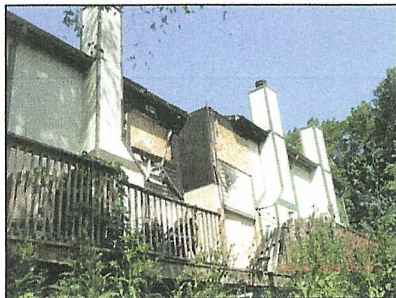
Fire damage

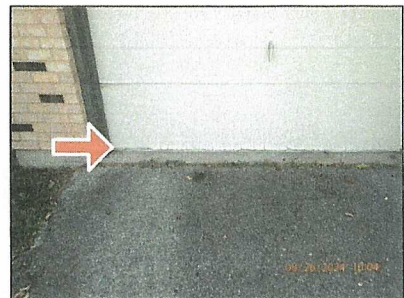
2026 - Deterioration at the garage door.

2026 - Deterioration at garage door.

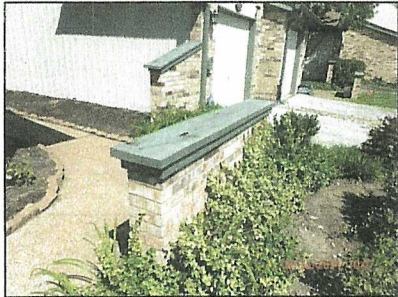
2023 - Noted deterioration at the wood entry wall cap.

2023 - Entry wall cap.

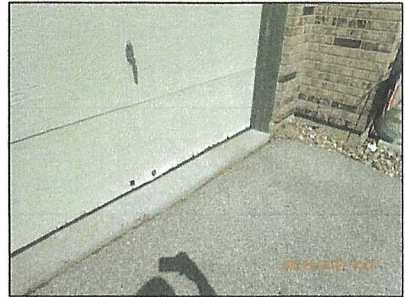
2025 - Deterioration at the bottom edge of the wood siding. Deterioration at the garage door.

2025 - Garage door deterioration.

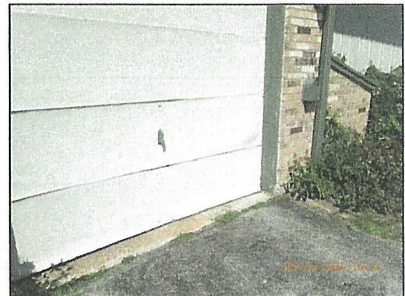
2039 - Deterioration/damaged garage door. Deterioration at the wing wall cap. Deterioration along the bottom edge of the siding.

2039 - Garage door deterioration.

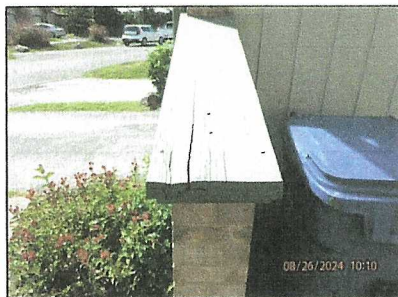
2039 - Deterioration at the wing wall cap.

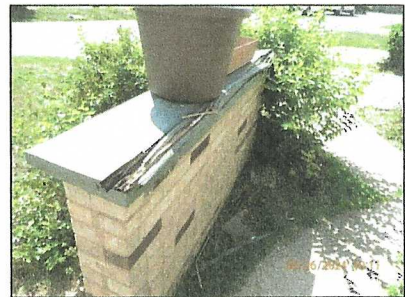
2041 - Deterioration at the entry wall cap. Damaged siding/trim at chimney.

2041 - Entry wall cap deterioration.

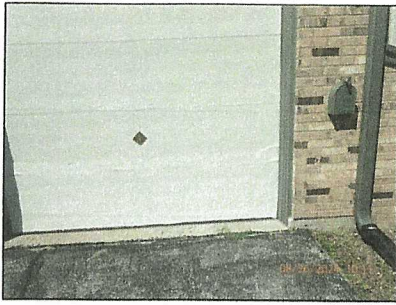
2043 - There is minor damage to the garage door, minor deterioration at the wing wall cap, and deterioration along the bottom edge of the siding. Damaged siding at the rear of the building and chimney.

2043 - Garage door damage.

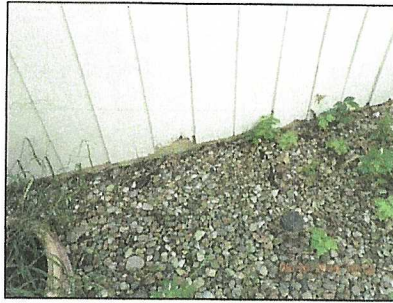
2043 - Deterioration at the bottom of the siding.

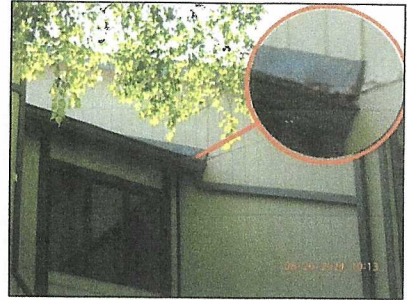
2045 - Deterioration at the trip above the roof line. Damaged siding at the chimney.

2045 - Deterioration at trim.

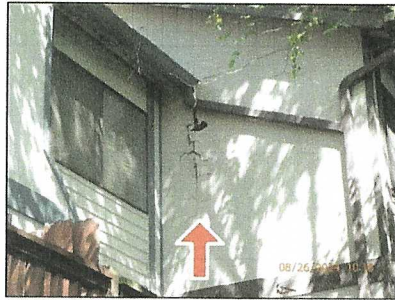
2043 - Damaed siding at rear of building.

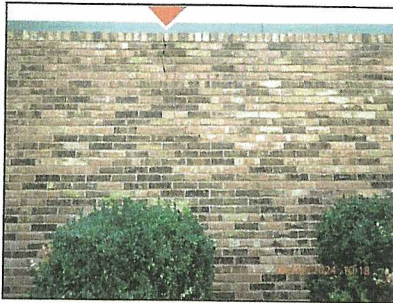
Sheared brick and stair step cracking at the north and south ends of the building possible due to settlement or foundation issues.

North end of building - sheared bricks

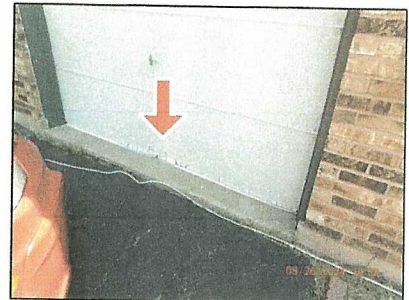
2048 - Deterioration at the garage door. Deterioration at the entry wall cap.

2048 - Garage door deterioration.

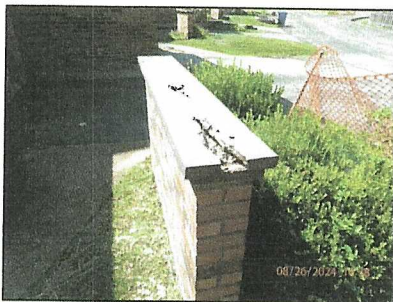
2048 - Entry wall cap deterioration.

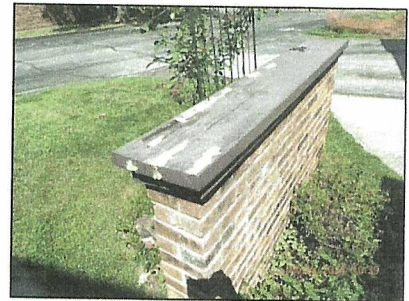
2044 - Paint entry wall cap.

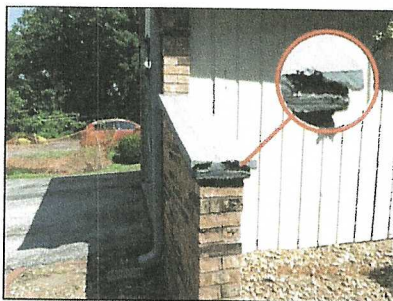
2044 - Wing wall cap wood decay.

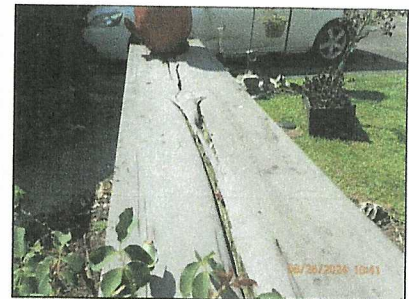
2036 - Entry wall cap deteriorated.

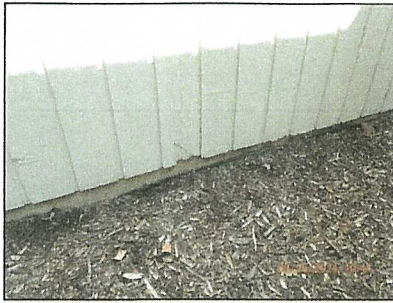
2028 - Minor deterioration at the bottom edge of the siding.

2028 - Minor deterioration at the bottom of the siding.

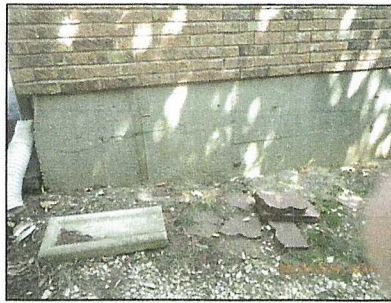
2026 - Cracked foundation wall.

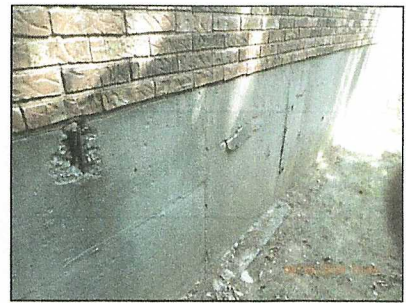
2026 - Exposed rebar in foundation.

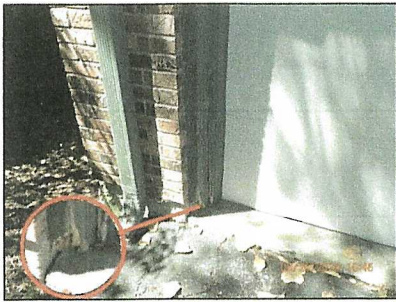
2025- Garage door jamb damage.

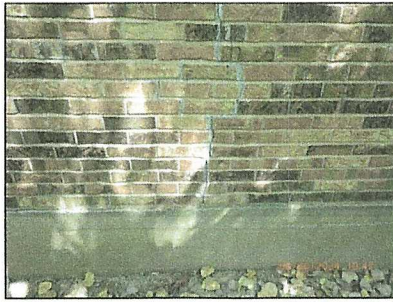
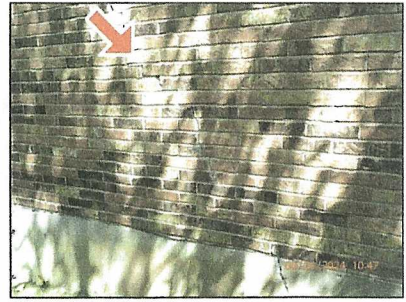
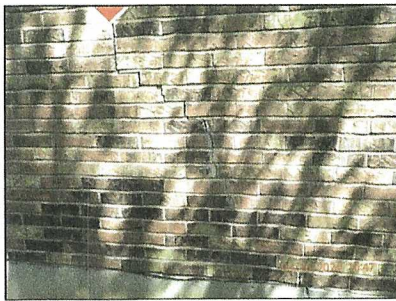
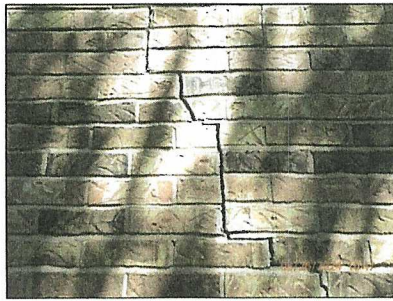
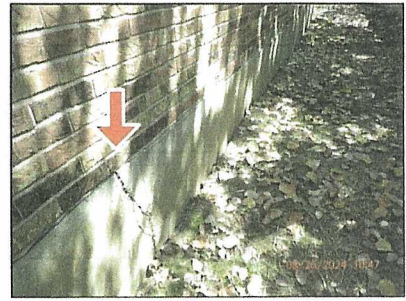
We noted sheared and cracked bricks with evidence of active movement/settlement at the end of the building, which has potential foundation issues. There is also exposed rebar protruding from the foundation wall. I recommend a foundation repair contractor to evaluate the conditions further.

End of building cracked bricks - possible foundation issues.

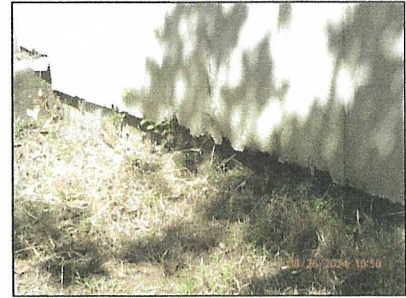
2031 - Deterioration at the bottom of the siding.

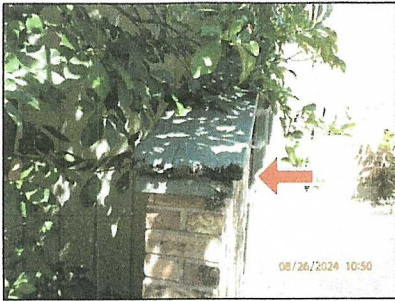
2031 - Deterioration at wing wall cap.

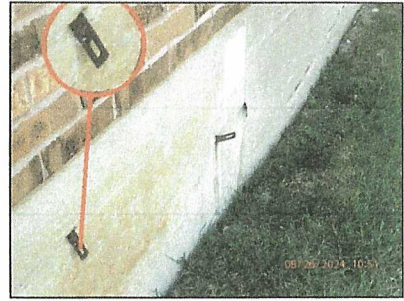
2035 - Remove the foundation ties. Noted a horizontal and vertical cracks in the foundation wall in need of repairs.

2035 - Foundation wall form ties.

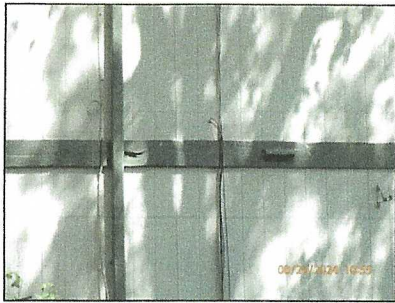
12116 - Wood rot at trim boards.

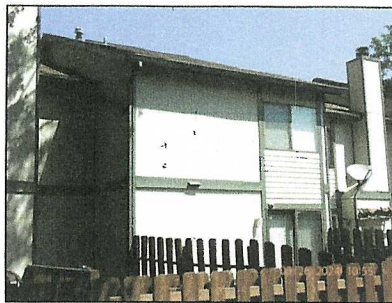
Peeling paint at the rear of the building

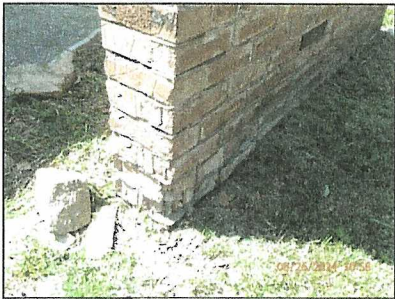
12110 - Entry wall damaged bricks.

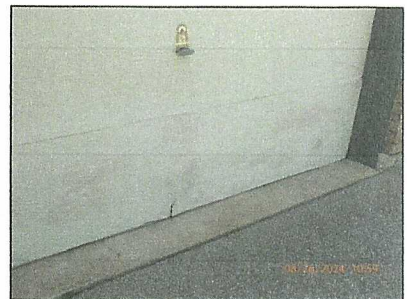
12118 - Deterioration at the garage door.

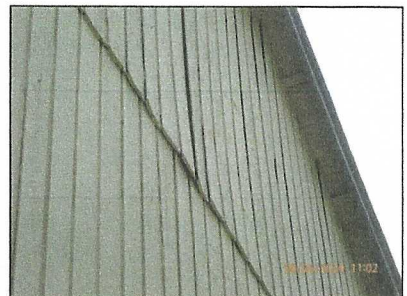
At the west end of the building the re is some cupped siding and foundation ties that should be removed.

West end of building cupped siding.
