**BPG Inspection, LLC**

**Rush Creek subdivision, Quite Stream, Falling Brook,  
Silent Spring, Painted Leaf, Rush Creek Way  
Maryland Heights MO 63043**

Client(s): HOA  
Inspection Date: 8/26/2024  
Inspector: Mark Goodman ,

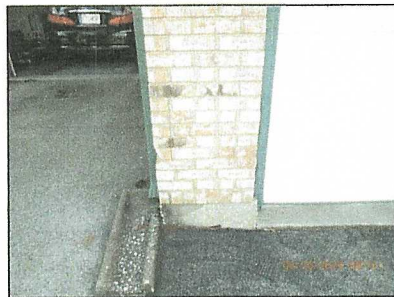
2042 - Sheared bricks at corner.

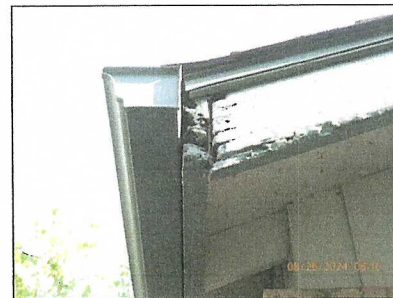
2044 - Gutter and rake boards.

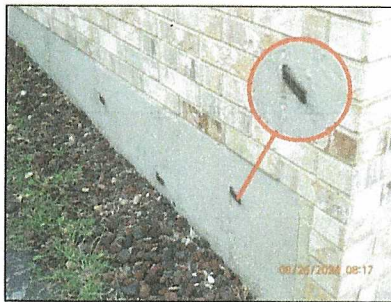
2034 - remove concrete form ties.

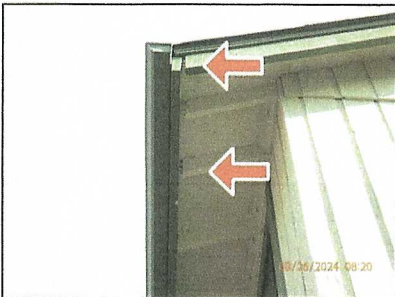
2030 - Loose gutter board.

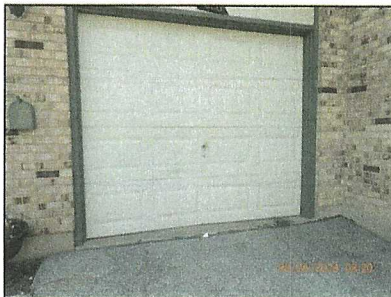
2028 Bent and damaged garage door.

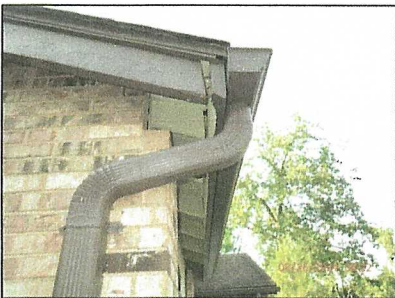
2022 - Loose gutter board.

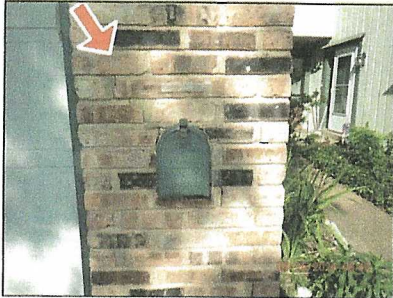
2029 - Sheared and cracked brick.

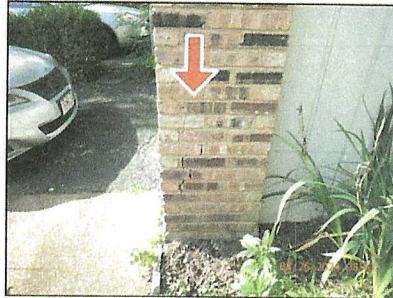
2029 - cracked brick and tuckpointing.

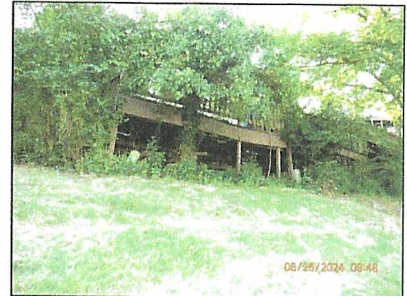
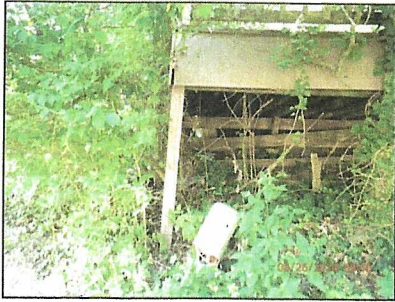
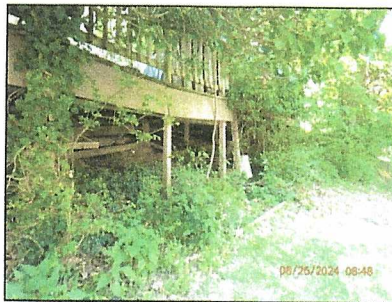
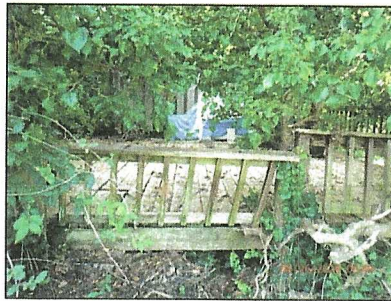
Decks- potential safety issues.

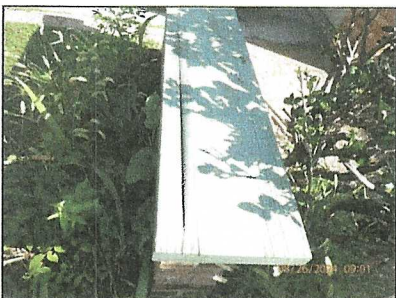
2048 - wood cap at entry wall.

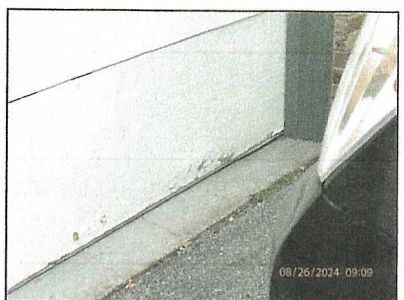
2028 - Garage door paint.

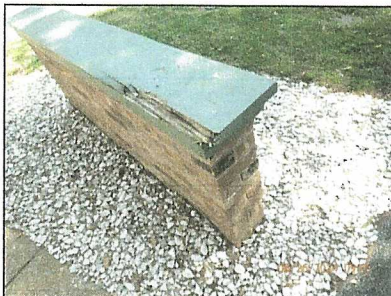
2027 - Damaged cap at entry wall.

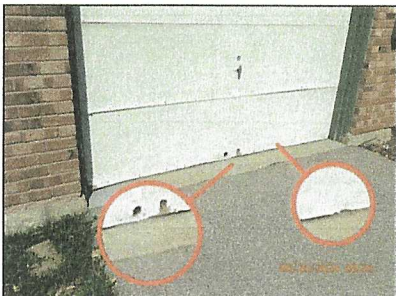
2031 - Deterioration at the garage door.

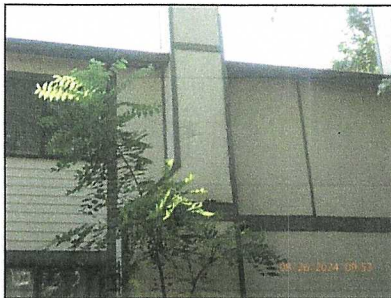
Siding at chimney.

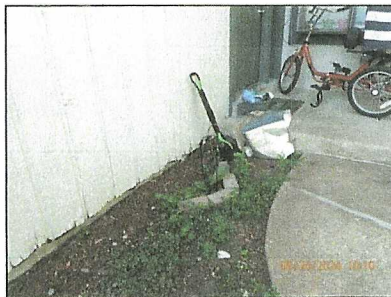
2039 - Deterioration/damaged garage door. Deterioration at the wing wall cap. Deterioration along the bottom edge of the siding.

2039 - Bottom edge of siding deterioration.

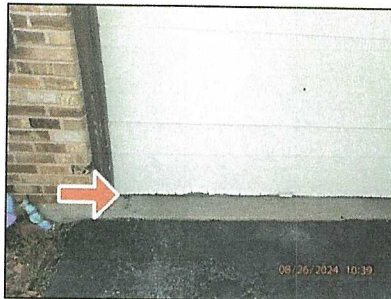
2046 - Deterioration at the garage door.

2046 - Garage door deterioration.

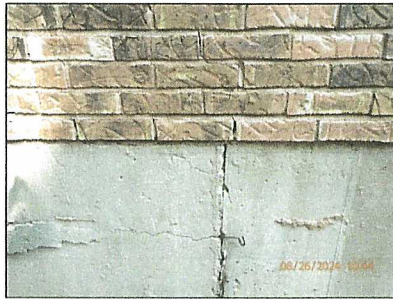
2026 - I noted a horizontal crack in the foundation wall with exposed rebar at the side of the garage that a foundation repair contractor should repair.

2026 - Cracked foundation wall.

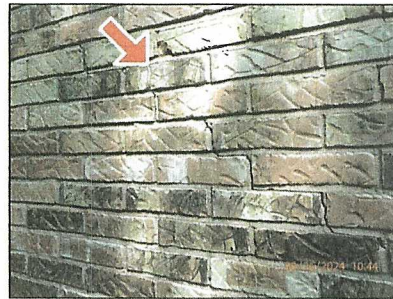
Sheared brick and stair step cracking at the north and south ends of the building possible due to settlement or foundation issues.

South end of building - stair step cracks in brick work.

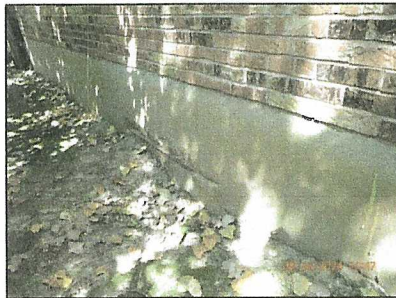
We noted sheared and cracked bricks with evidence of active movement/settlement at the end of the building, which has potential foundation issues. There is also exposed rebar protruding from the foundation wall. I recommend a foundation repair contractor to evaluate the conditions further.

Exposed rebar in foundation wall.

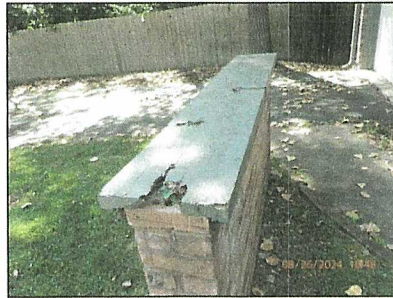
2027 - Deteriorated wood cap at the entry wall and peeling paint at the wing wall.

2027 - Deteriorated wood cap.

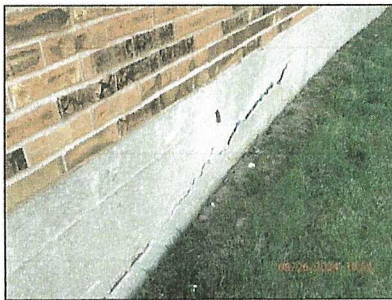
2035 - Remove the foundation ties. Noted a horizontal and vertical cracks in the foundation wall in need of repairs.

2035 - Cracks in foundation wall.

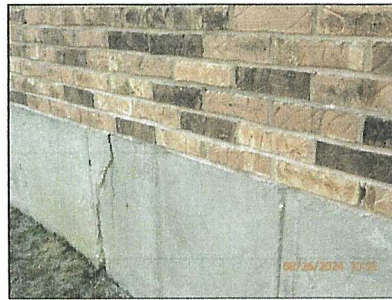
2035 - Cracks in foundation wall.

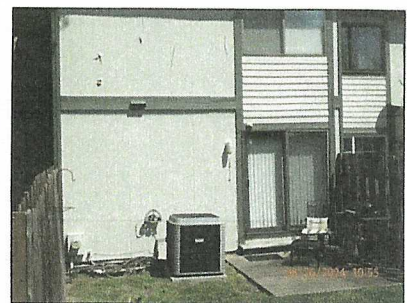
Peeling paint at the rear of the building

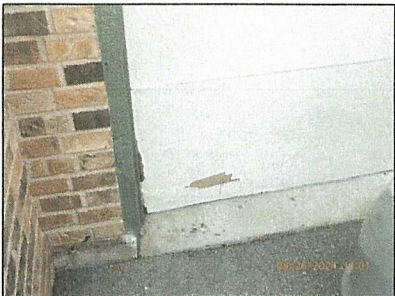
12126 - Deteriorated paint at the garage door.

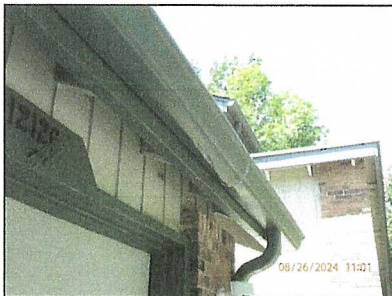
12126 - Bent and damaged gutter.
