**BPG Inspection, LLC**

**Rush Creek subdivision, Quite Stream, Falling Brook,  
Silent Spring, Painted Leaf, Rush Creek Way  
Maryland Heights MO 63043**

Client(s): HOA  
Inspection Date: 8/26/2024  
Inspector: Mark Goodman ,

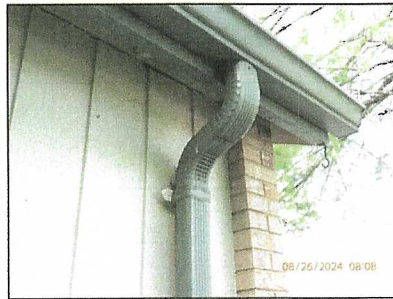
2044 - Loose downspout.

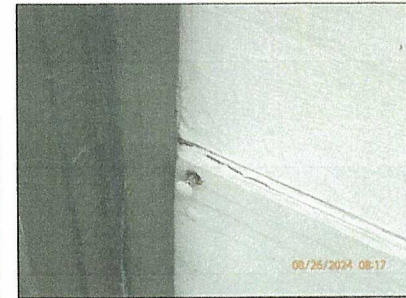
2036 - Garage door.

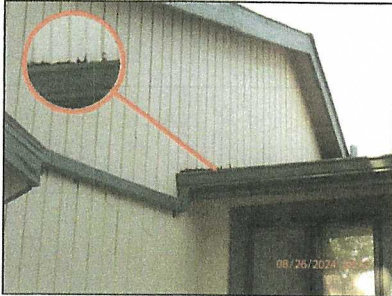
2025 - Deteriorated siding.

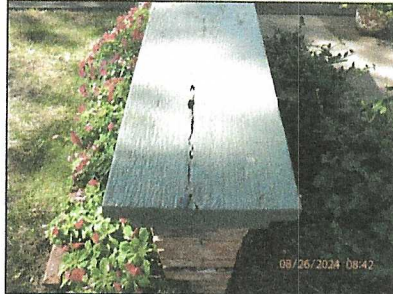
2025 - Entry wall cap.

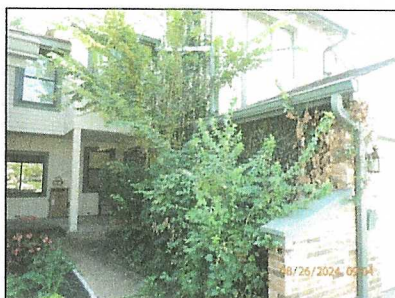
2042 - Vegetation

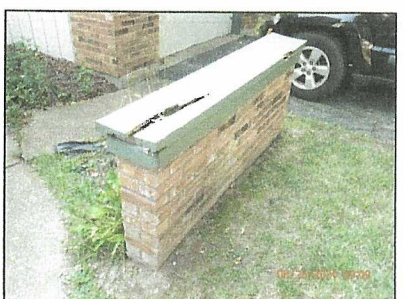
2028 - Entry wall cap.

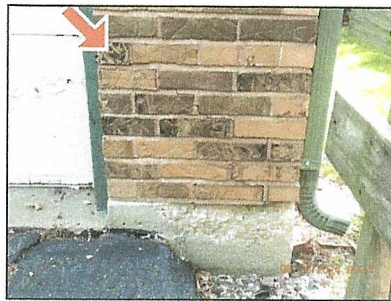
2026 - Brickwork.

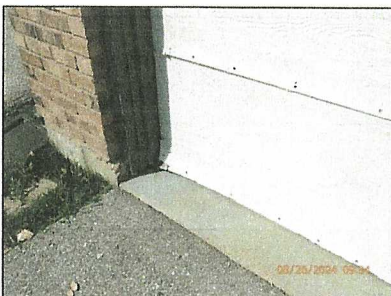
2031 - Garage door.

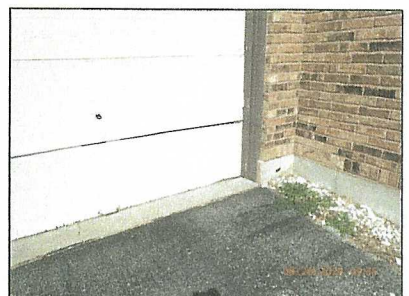
2023 - Garage door.

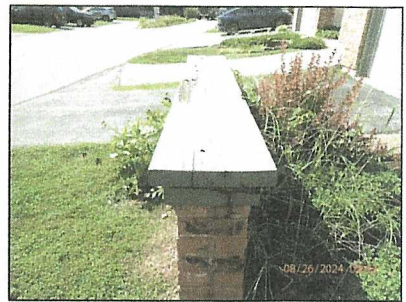
2047 - Entry wall cap.

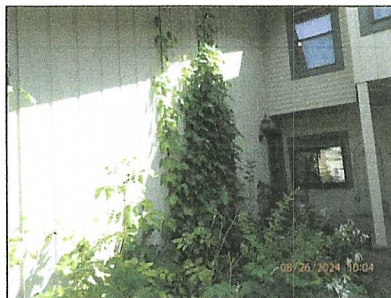
2030 - Overgrown vegetation.

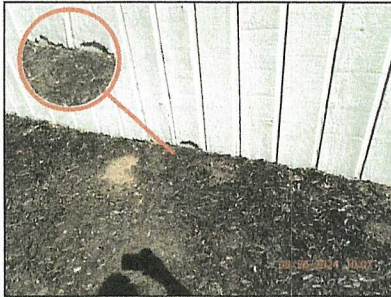
2025 - Deterioration at the bottom edge of the wood siding. Deterioration at the garage door.

2025 - Siding deterioration.

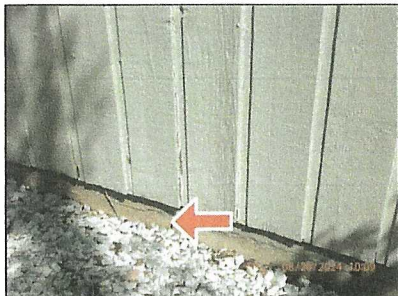
2033 - Loose and deteriorated siding along the bottom edge and caulking details.

2033 - Siding issues.

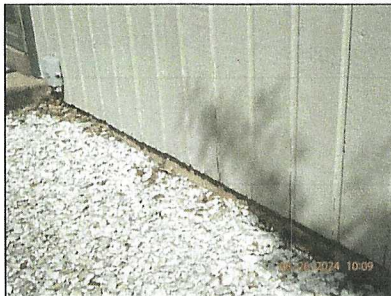
2033 - Siding issues.

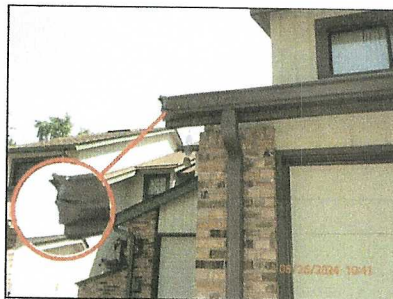
2036 - Bent and damaged gutter. Deteriorated entry wall cap.

2036 - Bent/damaged gutter.

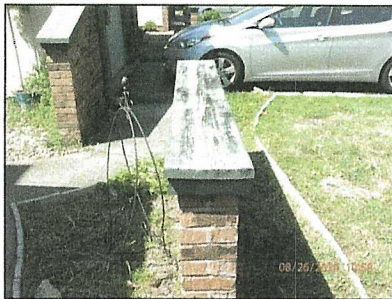
12110 - Entry wall cap.
